NASA-MSC-G-R-65-2
SUPPLEMENTAL REPORT 7

EVALUATION OF VELOCITY ERROR
IN IMU DURING ASCENT PHASE
(GEMINI 2 and GEMINI 3 MISSIONS)

REPORT B984

SUBMITTED UNDER Contract NAS 9-170 - Project Gemini

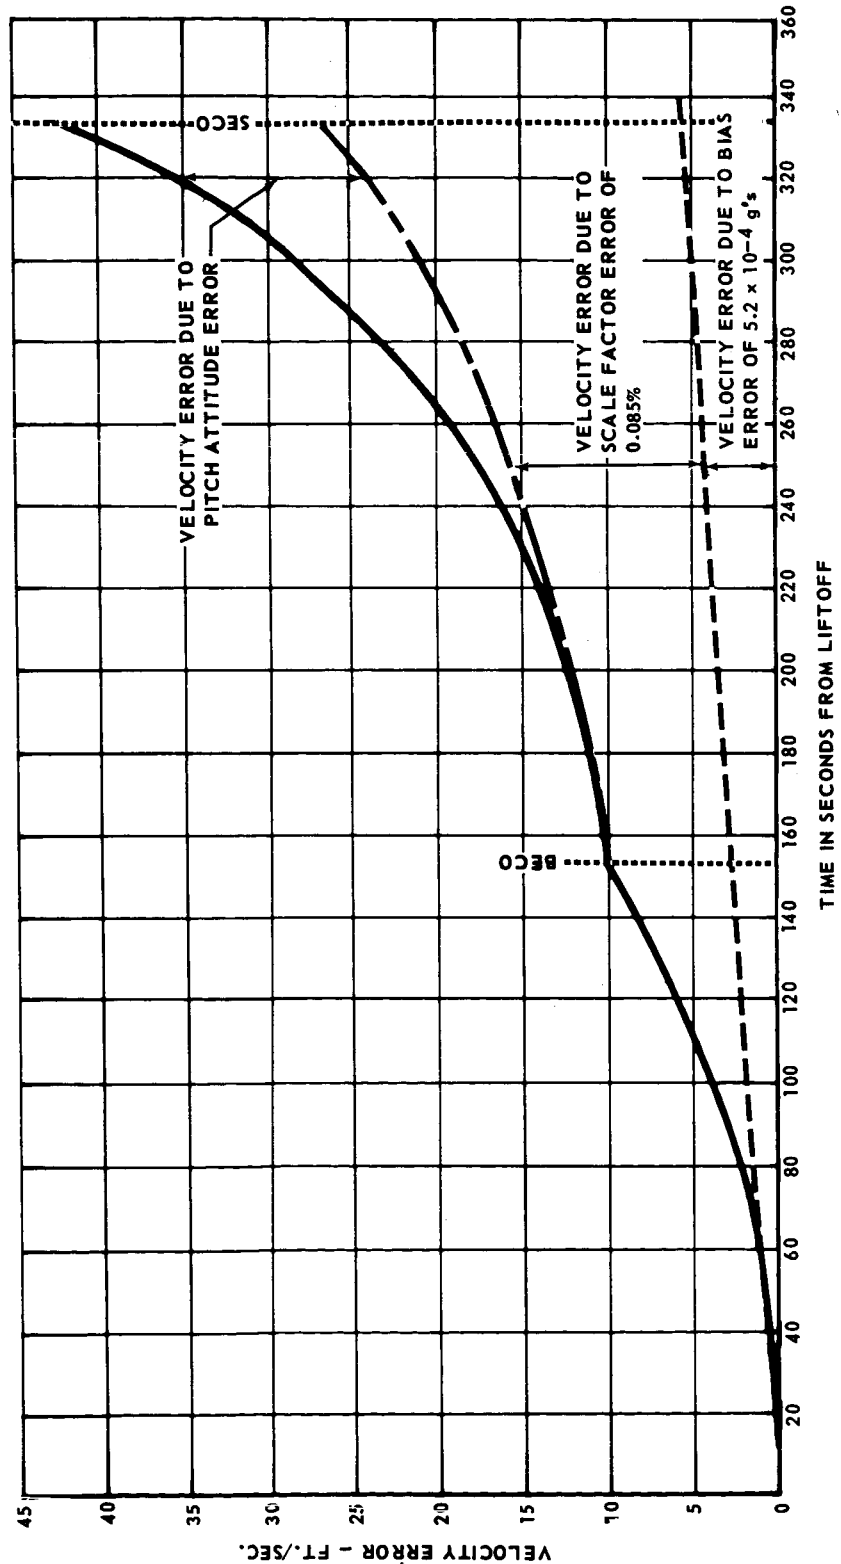
FIGURE 1

4.2.2.3 Y Gyro Anomaly.-- As noted on Figure 1, some residual longitudinal velocity error was attributed to a possible pitch attitude error. An investigation was conducted to determine the cause of this pitch attitude error. During standard ATP orientation checks the Y gyro, S/N H-11, which controls the pitch axis, indicated an erroneous and erratic acceleration sensitivity. When testing the

**GT-3
X AXIS ERROR SOURCES VS. TIME**

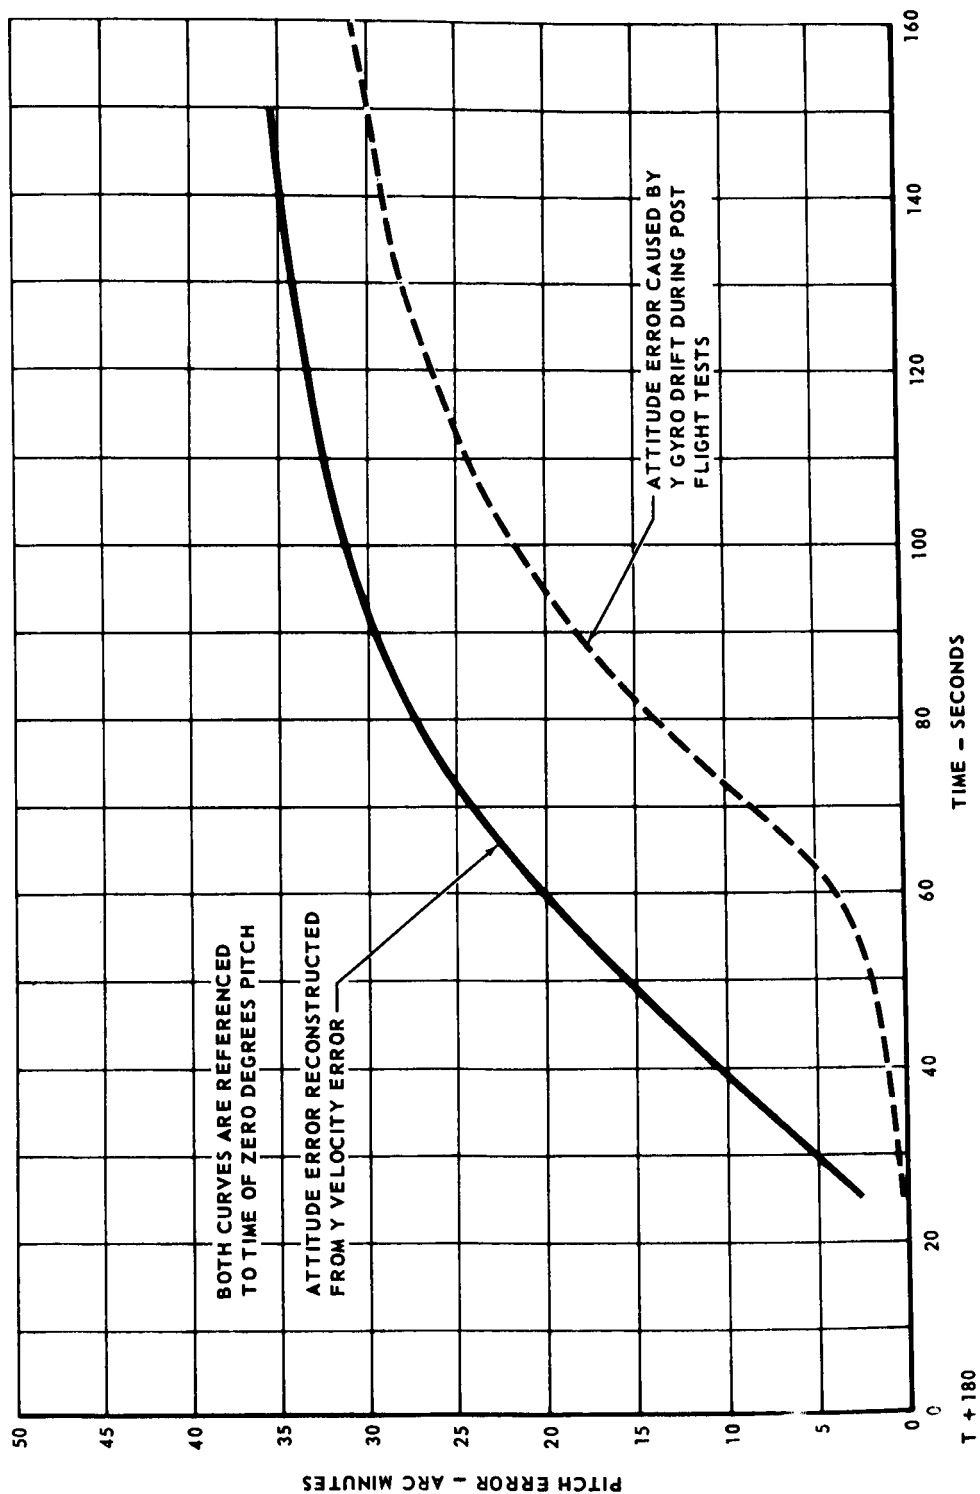
FIGURE 10

Additional substantiation that the Y gyro was a major contributor to the S/C #3 ascent problem is indicated in Figure 10. This plot indicates a predicted pitch attitude error reconstructed from the vertical velocity error during the Stage II flight and a typical pitch attitude error constructed using Y gyro drifts observed during the post flight simulation test. A comparison

of these plots indicates general agreement verifying that the pitch attitude error was caused by the defective Y gyro.

GT-3 PITCH ATTITUDE ERROR VS. TIME

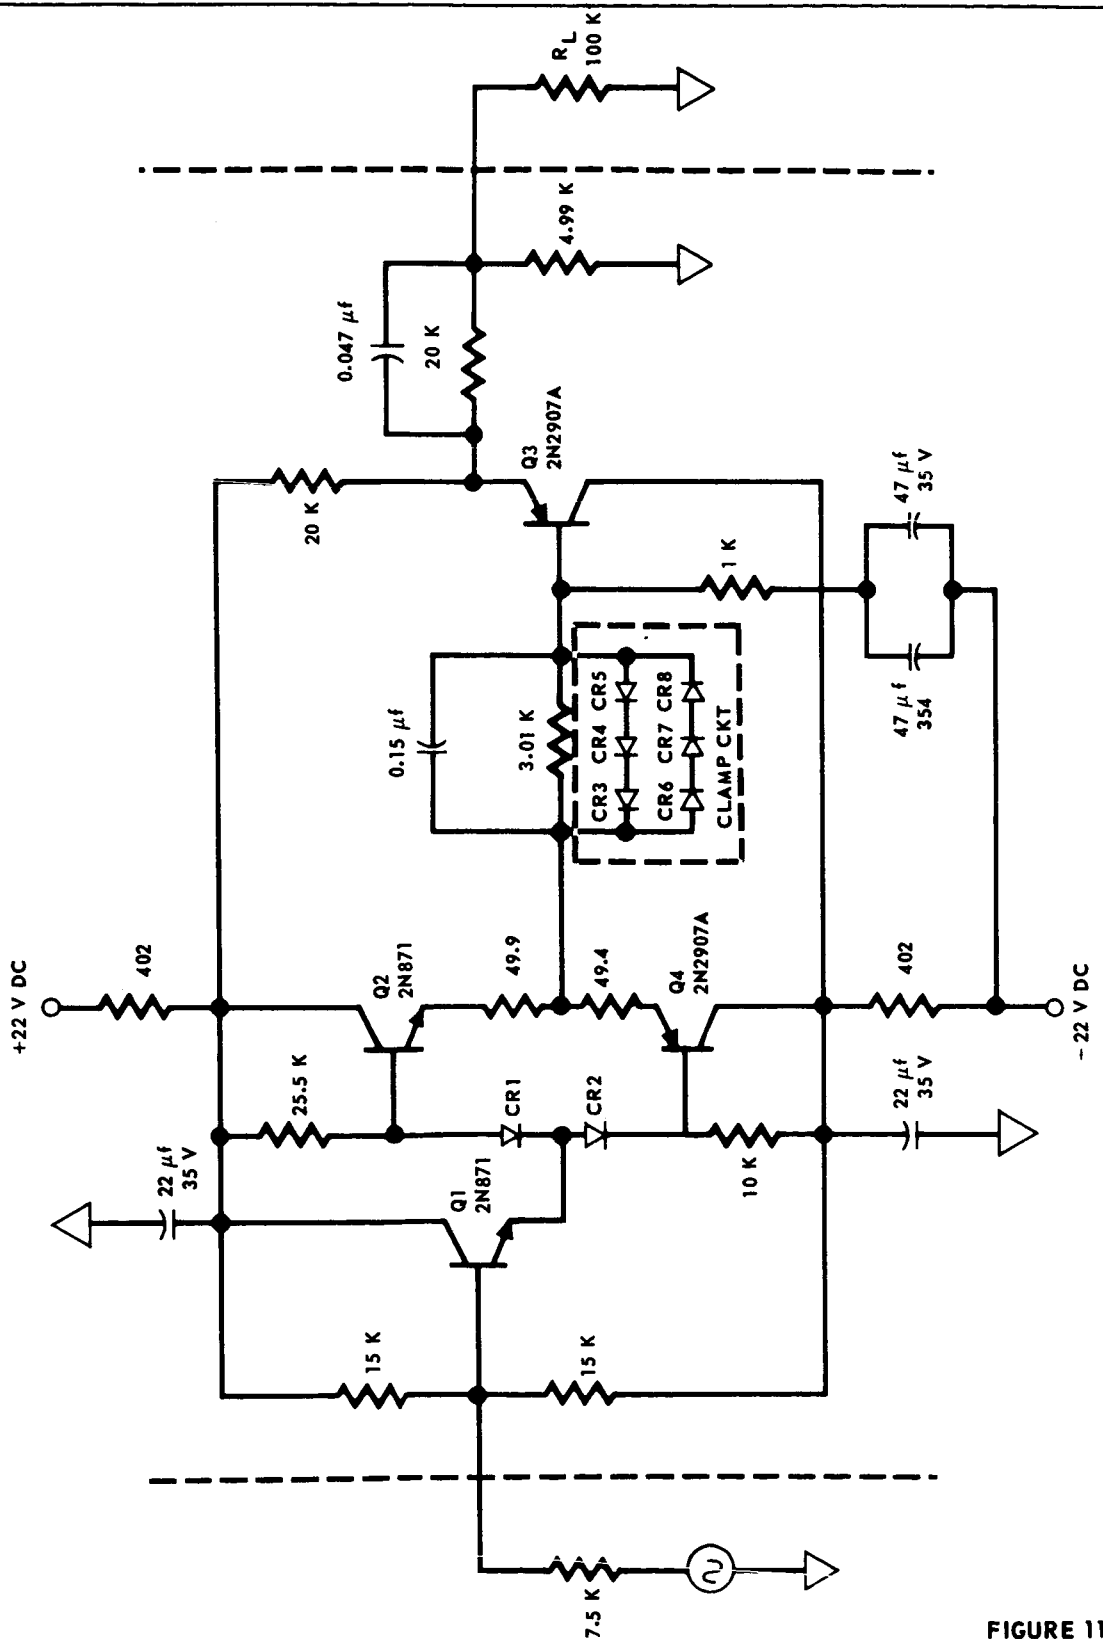
FIGURE 11

4.2.2.2 X Accelerometer Anomaly.-- Tests on the X accelerometer in the S/C #3 platform verified it as a significant contributor to the longitudinal velocity error. A history of the X accelerometer scale factor and bias measurements are presented in Figure 7. A portion of the shifts noted on Figure 7 can be attributed to differences in cabling between Honeywell and the Cape; however, some variance is due to instability in the X accelerometer pulse rebalance loop. Tests at the vendor verified the instability. This loop was modified to correct an acceleration sensitive error noted during GT-2 flight. After incorporation of the modifications for GT-3, further refinements were included effective S/C #4 and up. The latest accelerometer loop modification has eliminated the GT-3 stability problems.

SPACECRAFT 3 RATE NETWORK

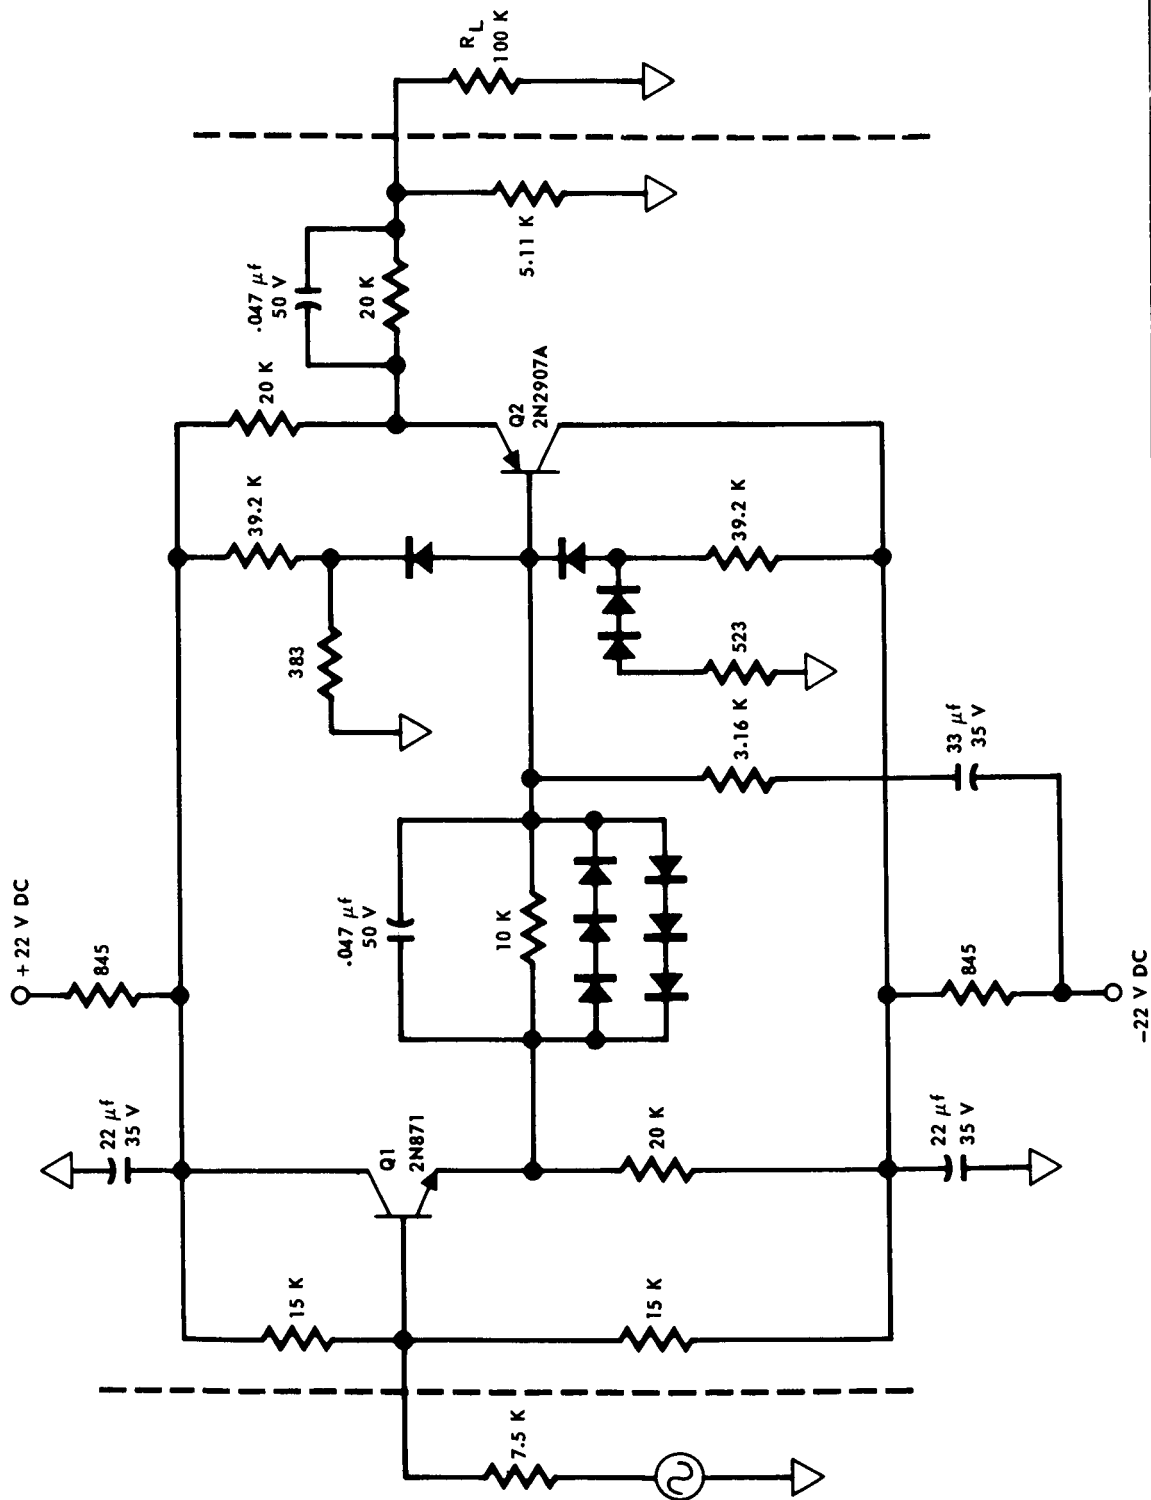
FIGURE 12

FINAL RATE NETWORK S/C-4 AND UP

5.1.2 Corrective Action S/C #4 and Up.- As indicated in paragraph 4.2.2.2, the network described in Paragraph 5.1.1, caused the accelerometer bias and scale factor terms to be unstable. In addition there is a potential PRE loop turn-on problem. During the course of the PRE loop investigation it was found that the level detector output to the digital circuitry was lost when the level detector input signal exceeded 350 millivolts. This presented no problem during active loop operation but presented a possible problem when the loop was first turned on. If, at the instant of turnon, the accelerometer pendulum was against the stop
